**AIRPHOTO PATTERNS OF SOILS
OF THE
WESTERN UNITED STATES**

As Applicable to Airport Engineering

Technical Development Report No. 85

**U.S. DEPARTMENT OF COMMERCE
CIVIL AERONAUTICS ADMINISTRATION**

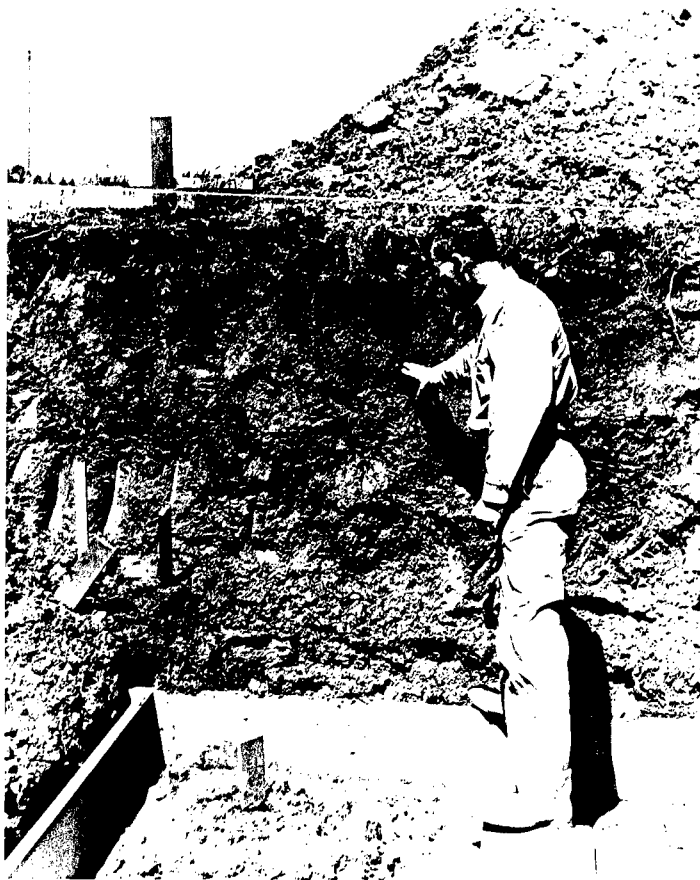
FIGURE 5.—*Lake Agassiz Silt.* This is an exposed profile of deep silt associated with the silt portions of Glacial Lake Agassiz.

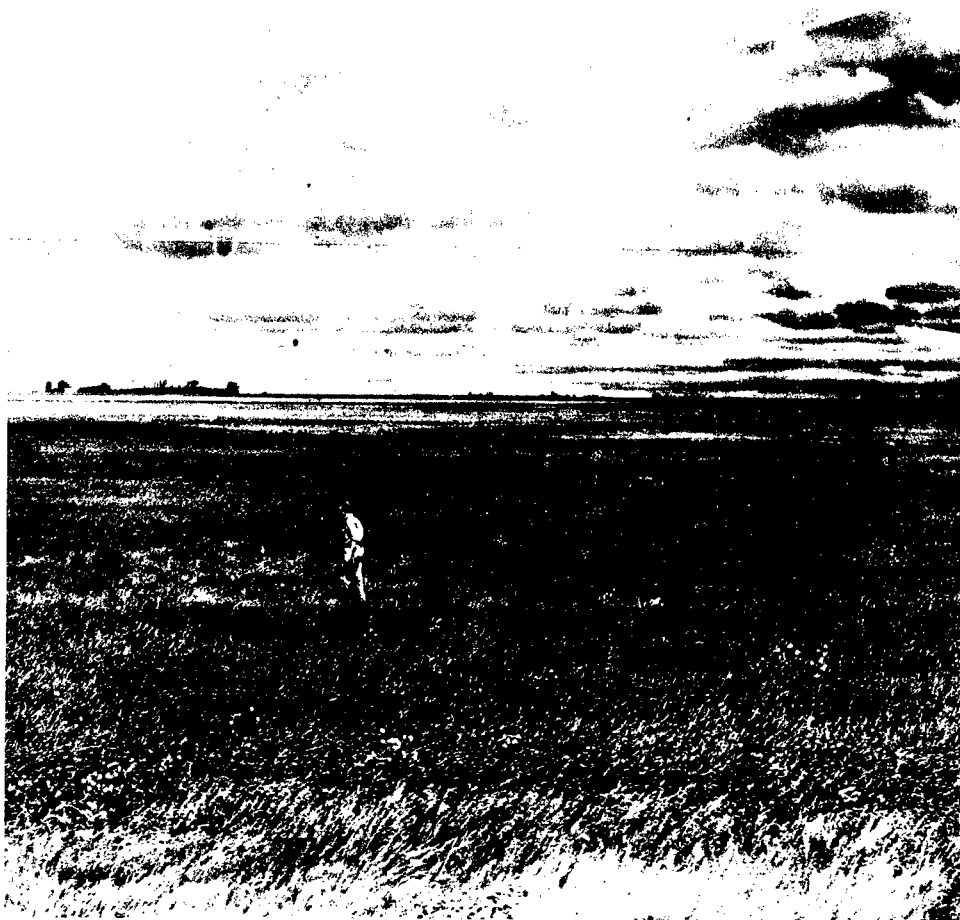
FIGURE 7.-- *Alkali Depression.* Note the vegetative change associated with this alkali spot. (The man is in the center of the alkali depression.) Such depressions occur in plastic clays of lakebed regions where evaporation is higher than precipitation. Alkali spots can be detected in airphotos by the change in vegetation and general light color tone. Note the flat topography and the absence of trees (Fargo, N. Dak.).

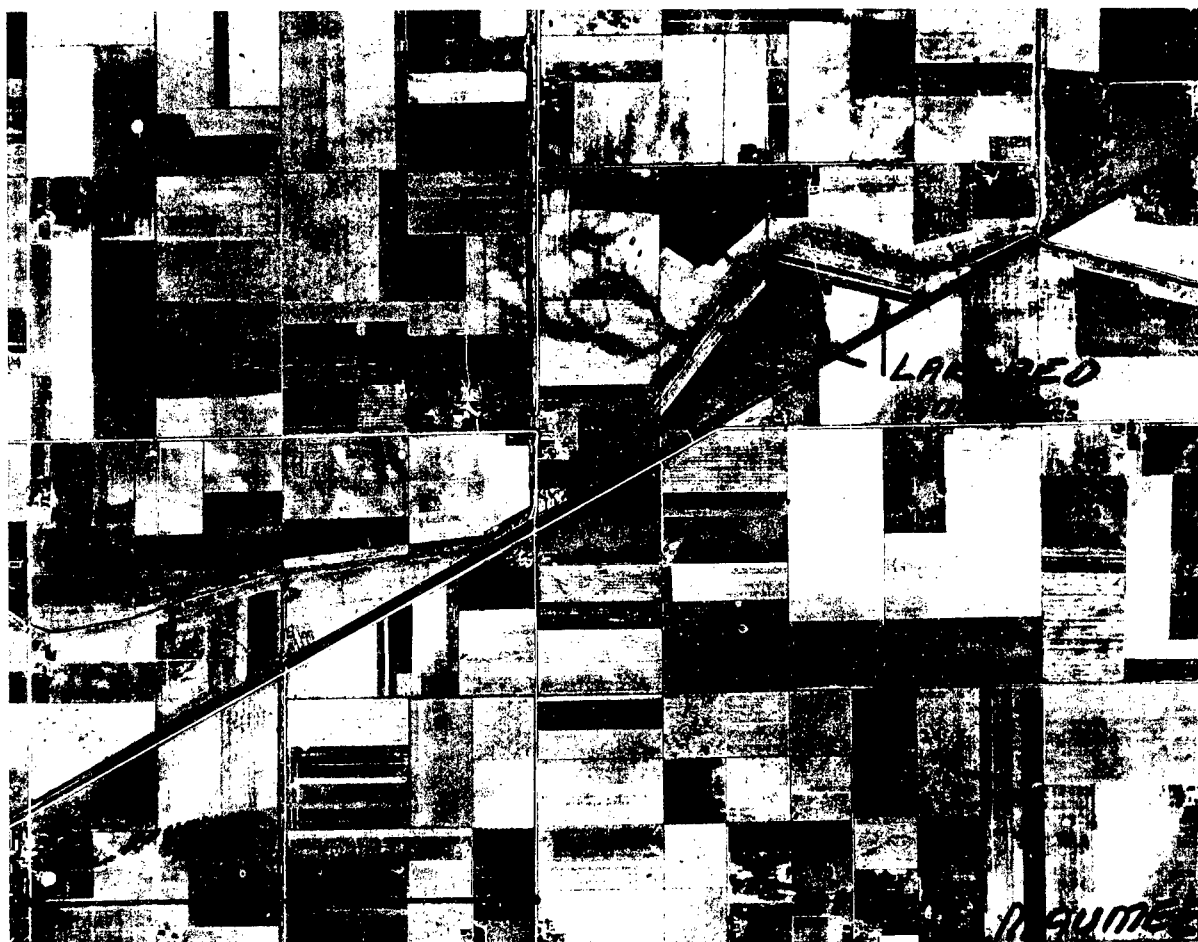
FIGURE 12.—*Glacial Lake Maumee.* This photo shows the airphoto pattern typical of glacial Lake Maumee which is that of deep lacustrine clay and silty clay. The dark areas are slightly depressed, contain greater quantities of organic material, and have a high ground-water table. Note the gully; gullies of this type are definite indicators of lacustrine soils. The topography is flat, such as that of Agassiz and the portion of Souris not yet reduced by erosion. The topsoil is organic and of varying depth, depending on the topographic position. The subsoils consist chiefly of plastic clays and silty clays. Glacial Lake Maumee also contains a series of fringing granular beach ridges, some of which serve as locations for major United States highways.

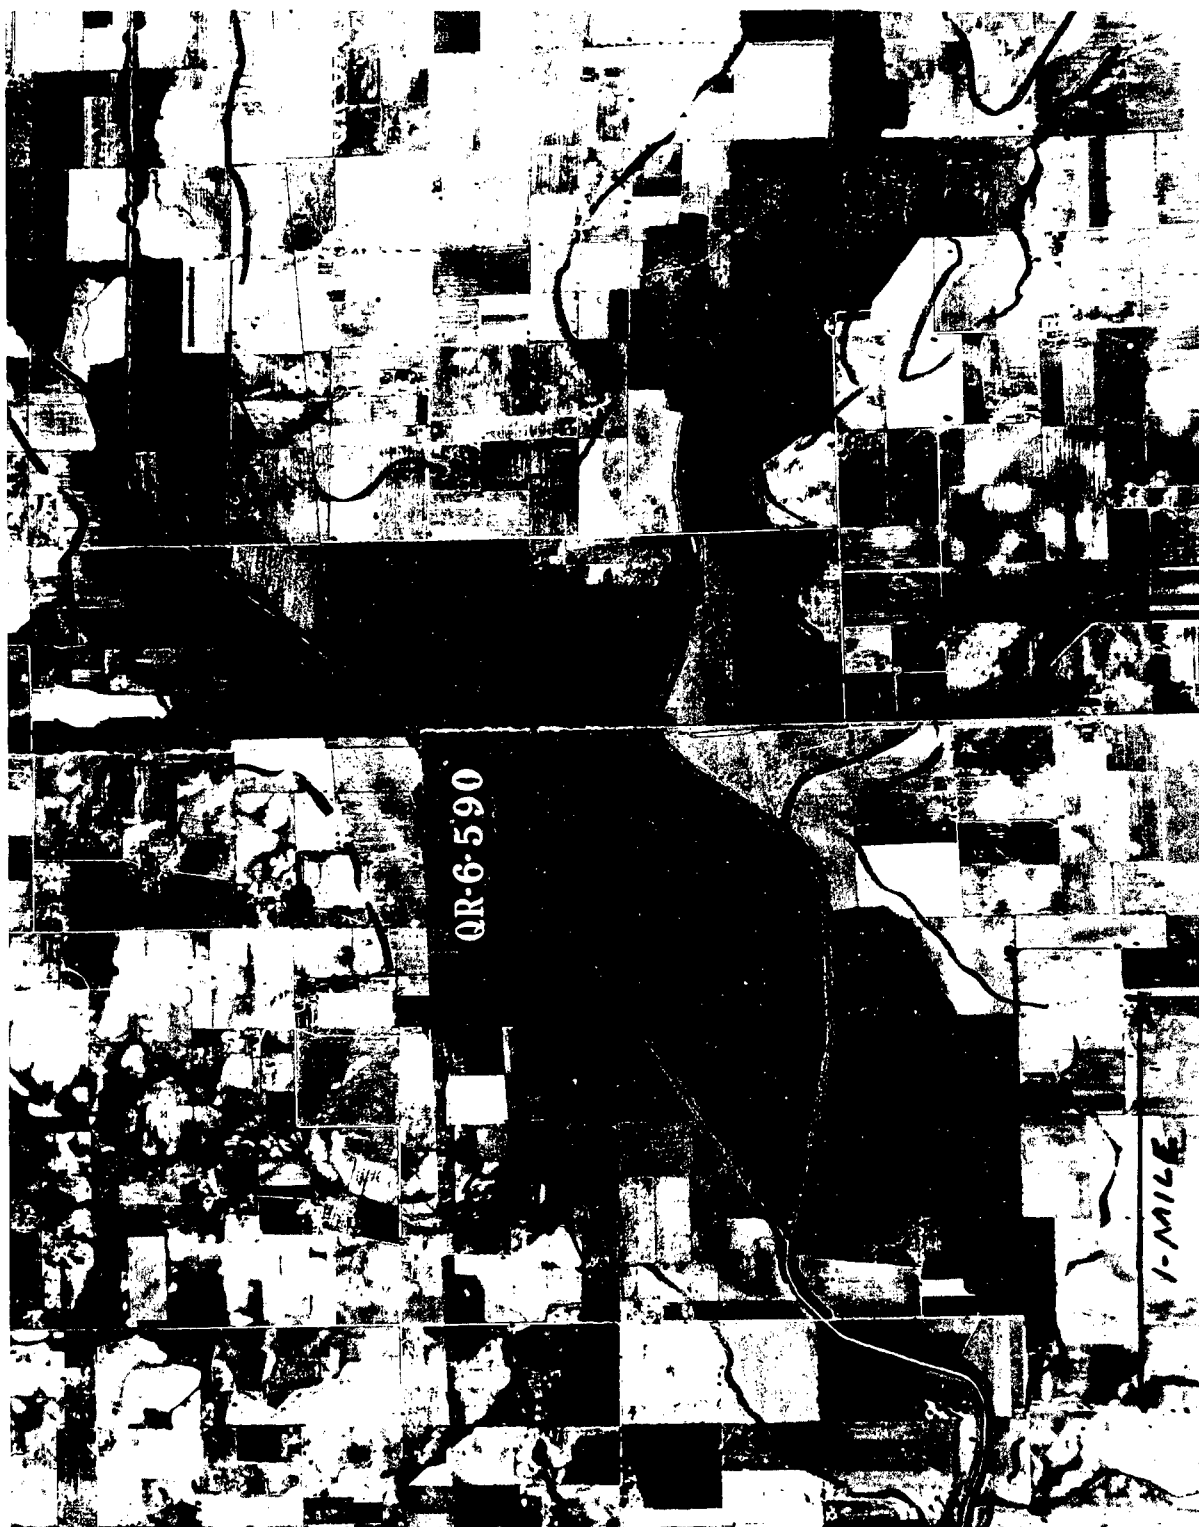
FIGURE 13.—*Lakebed in an Illinoian Glacial Drift Area.* This southern Indiana lakebed is characteristic of the many swampy, undrained lakebeds of glacial origin. The lacustrine soils are deep silts and silty clays, gray in color, and highly mottled. The characteristic feature of this pattern is the sharp contrast between lakebed and upland—indicated by the change in vegetation, active upland erosion, dark gray to black lakebed color, and heavy growth of timber. These lakes rarely exhibit beach lines or terraces.

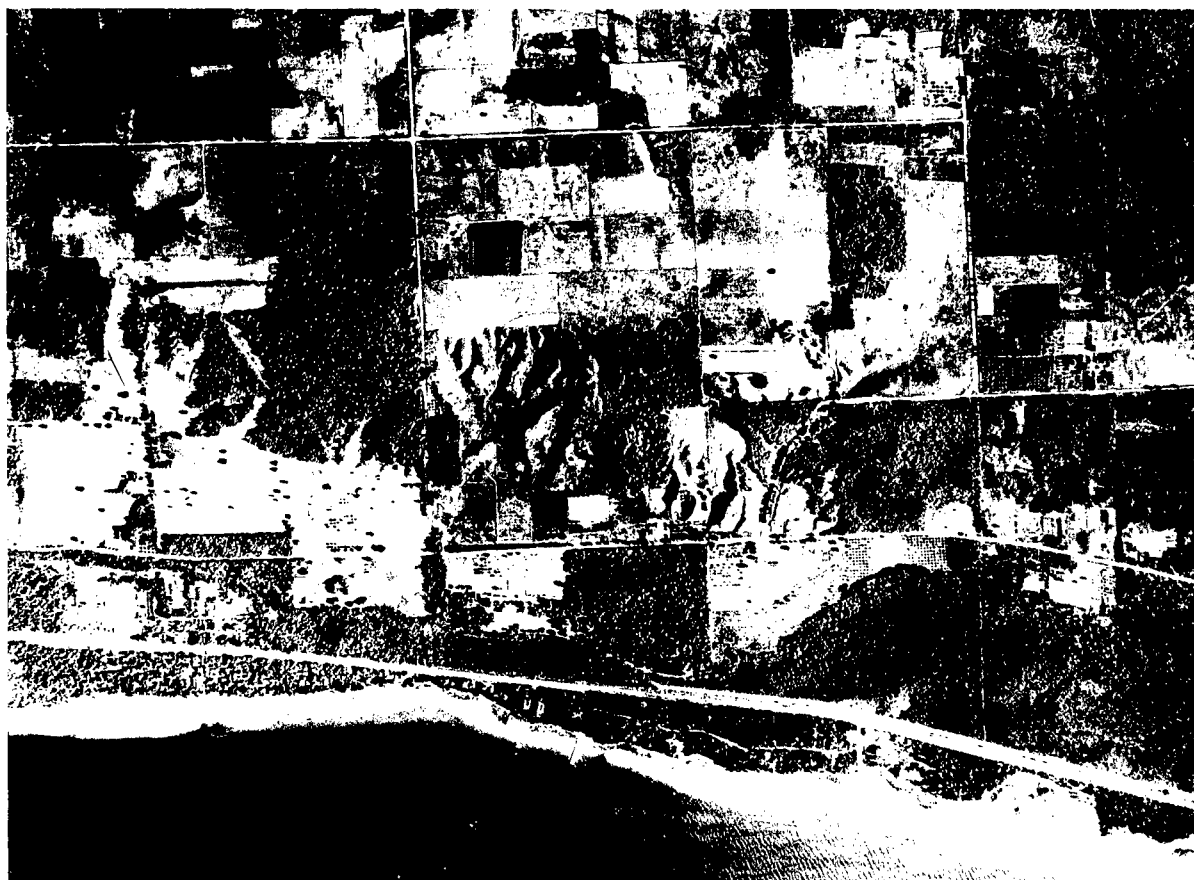
FIGURE 15.—*Glacial Lake Beaches.* This northern Michigan airphoto shows the pattern of two distinct glacial lake beaches now occupying the topographic position of terraces. Note the erosional features accompanying each change in slope. The beaches in this instance are granular. See figure 16 for a ground view of a similar situation occurring near Duluth, Minn.

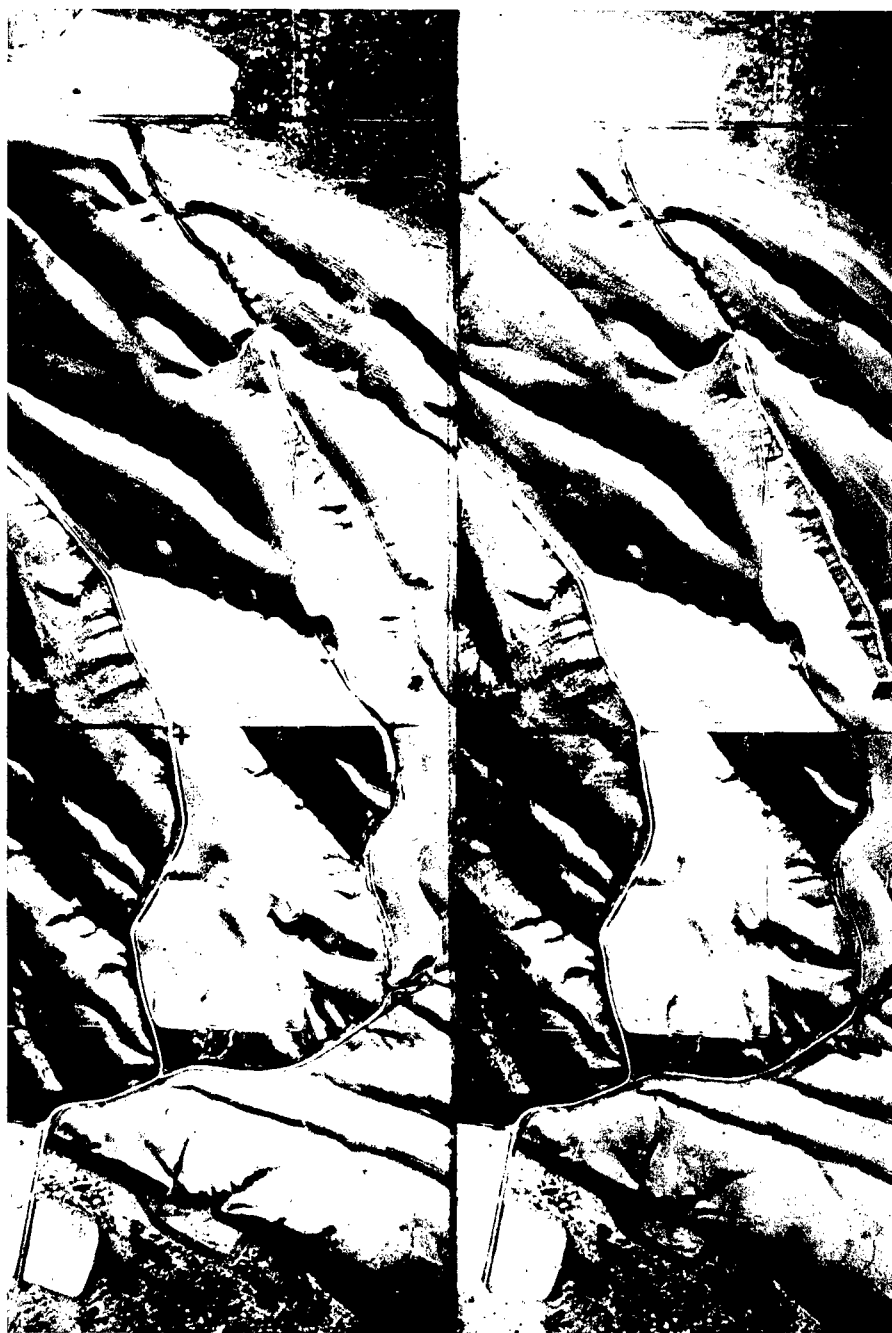
FIGURE 26. *Stereopair of One Type of Palouse Loess, Showing Land Form, Drainage Pattern, Gully Systems, and Land Use Typical of the Rolling Palouse Areas (Adams County, Wash.).* Note that the land form is quite rolling yet the hills are very softly rounded never angular. The drainage of the area consists of a system of parallel gullies, the laterals of which are short and enter at right angles, thereby creating the "fishbone," or pinnate, drainage pattern. Such elements as "cat steps" and pinnacles are not contained in this view because gully erosion has been checked by proper agricultural practices.

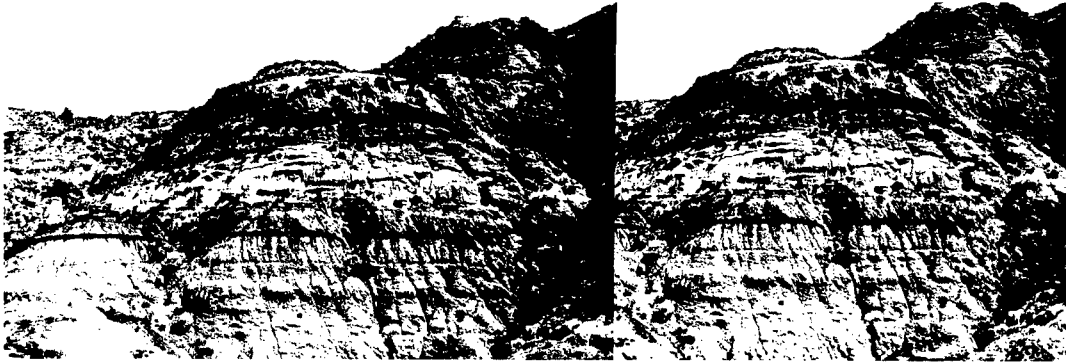
FIGURE 51.—*Broken Land Form of Shale with Sandstone.* This stereopair was taken at location 2 in figure 49 and shows a detailed view of sandy and clay shales and associated weathering of the shale member (Lebo). Note the many changes in shape and slope as layers of varying resistivity are crossed by erosional scars. This causes a broken land form.

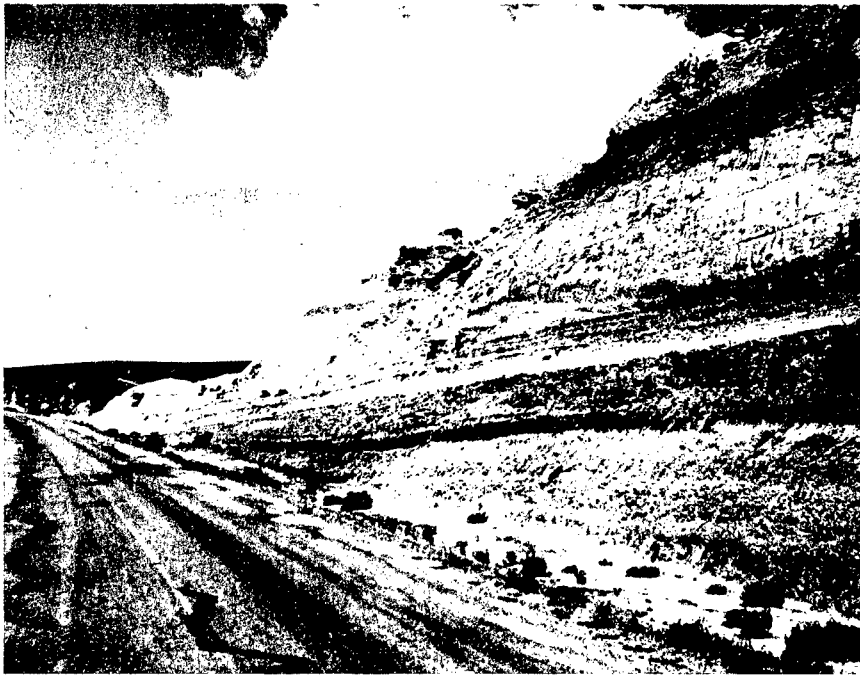
FIGURE 52.—*Highway Cut in Shale.* The numerous patches in the flexible pavement illustrate the engineering characteristics of this material. (See location 3 in fig. 49.)

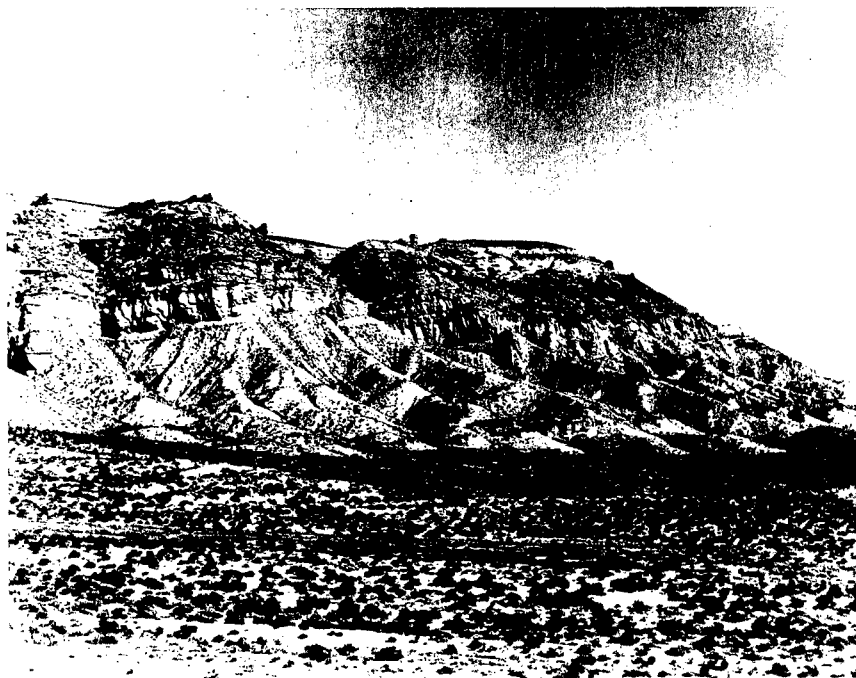
FIGURE 62.—*Shale (Cody) Capped with Sandstone and Shale (Mesa Verde).* This is 6 miles east of Rock Springs, Wyo. Note the difference in the erosion on sandstone and on the shale. This difference is one of the outstanding features used to separate the two types of rock when viewed in matched pairs of airphotos.

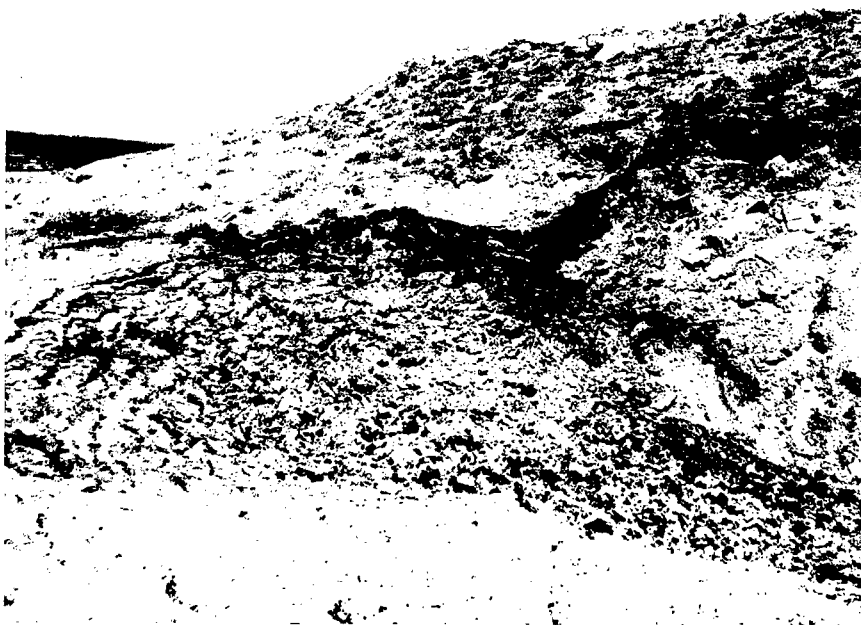
FIGURE 64.—*Scoria in the Making, near Hanna, Wyo. (Mesa Verde formation), from the Burning Lignite Beds. Here the soil has settled where underlying lignite beds have been burned.*

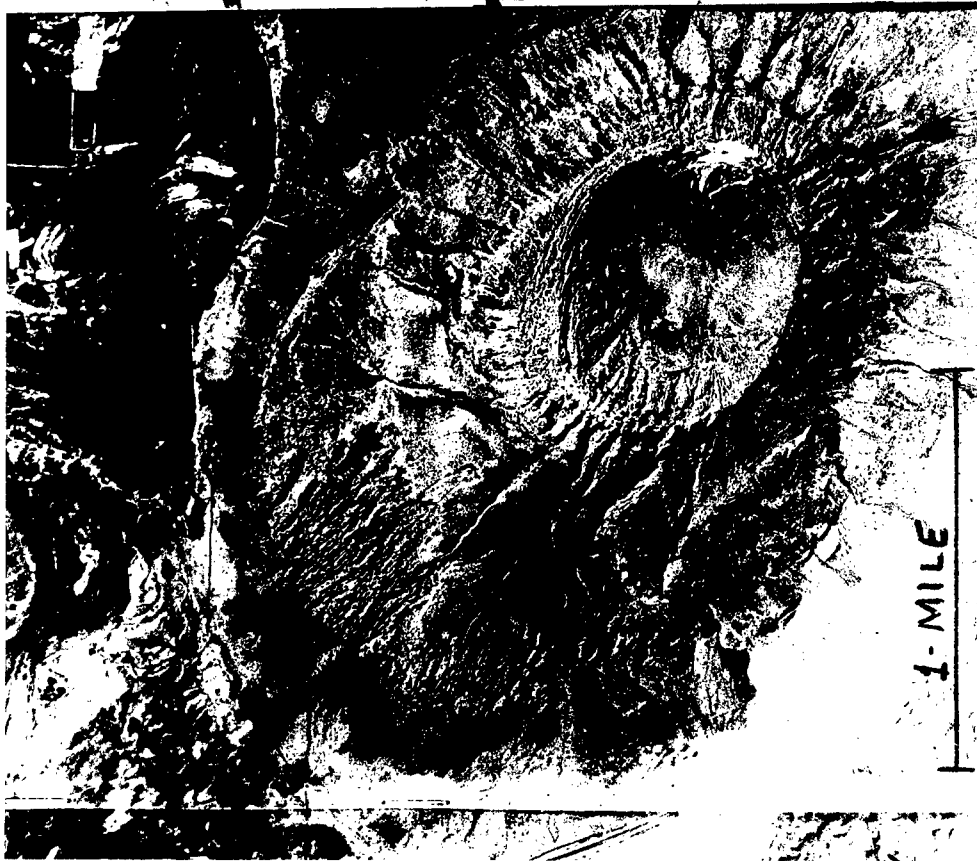
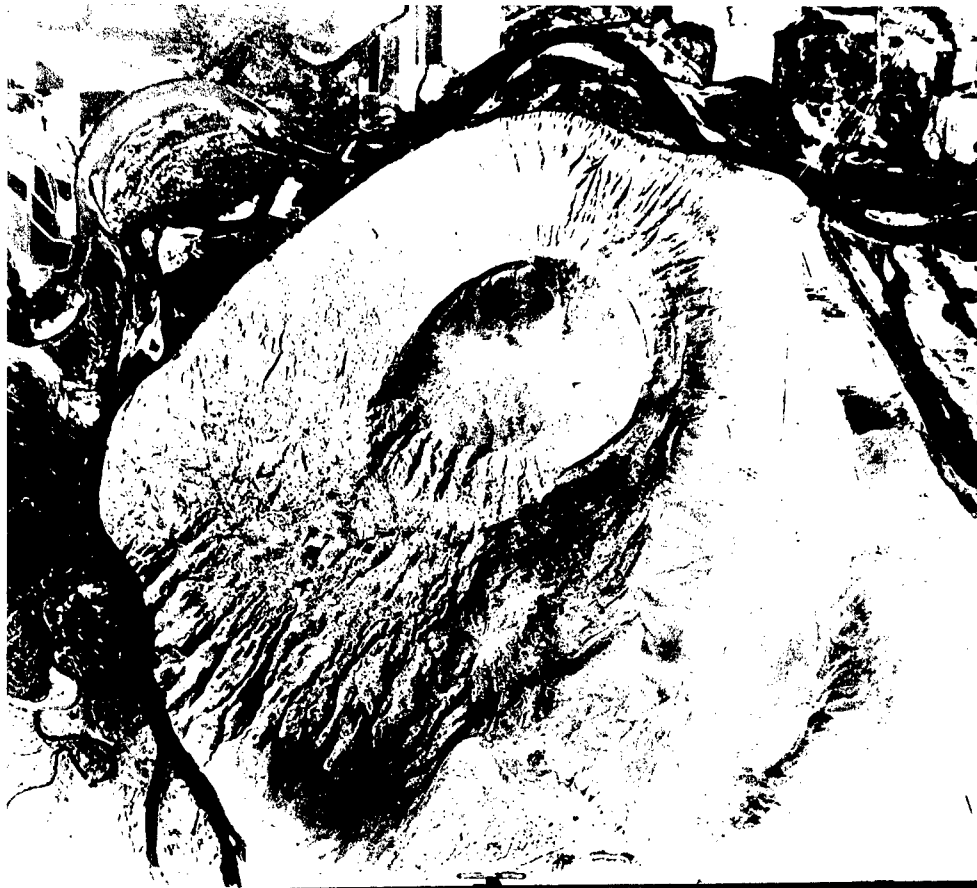
FIGURE 65.—*Volcanic Cinder Cones*. This Jefferson County, Idaho, photo depicts two cinder cones built up of volcanic ash and breccia. Note the radial drainage pattern. This is on the edge

of a basalt plateau consisting of an older flow material. The large size of the craters is indicated by the mile scale.

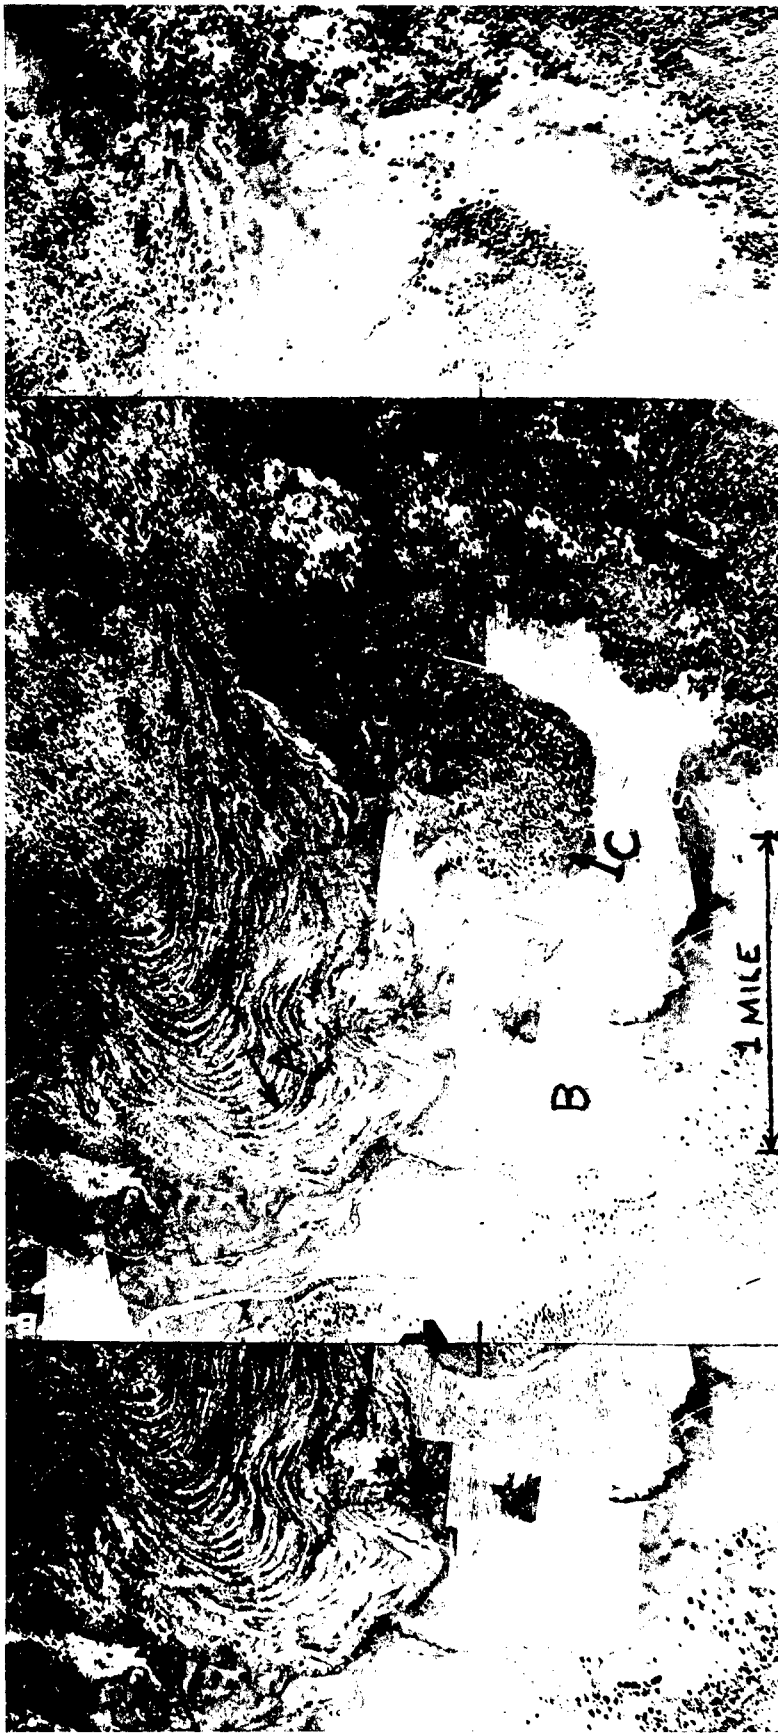
FIGURE 68.—*Stereotriple of a Lava Flow.* This Shasta County, Calif., area contains: *A*, the most recent lava flow; *B*, an older flow covered with pumice and volcanic breccia; *C*, an old crater or volcanic channel. The most recent flow has not weathered sufficiently to produce soil for timber growth.

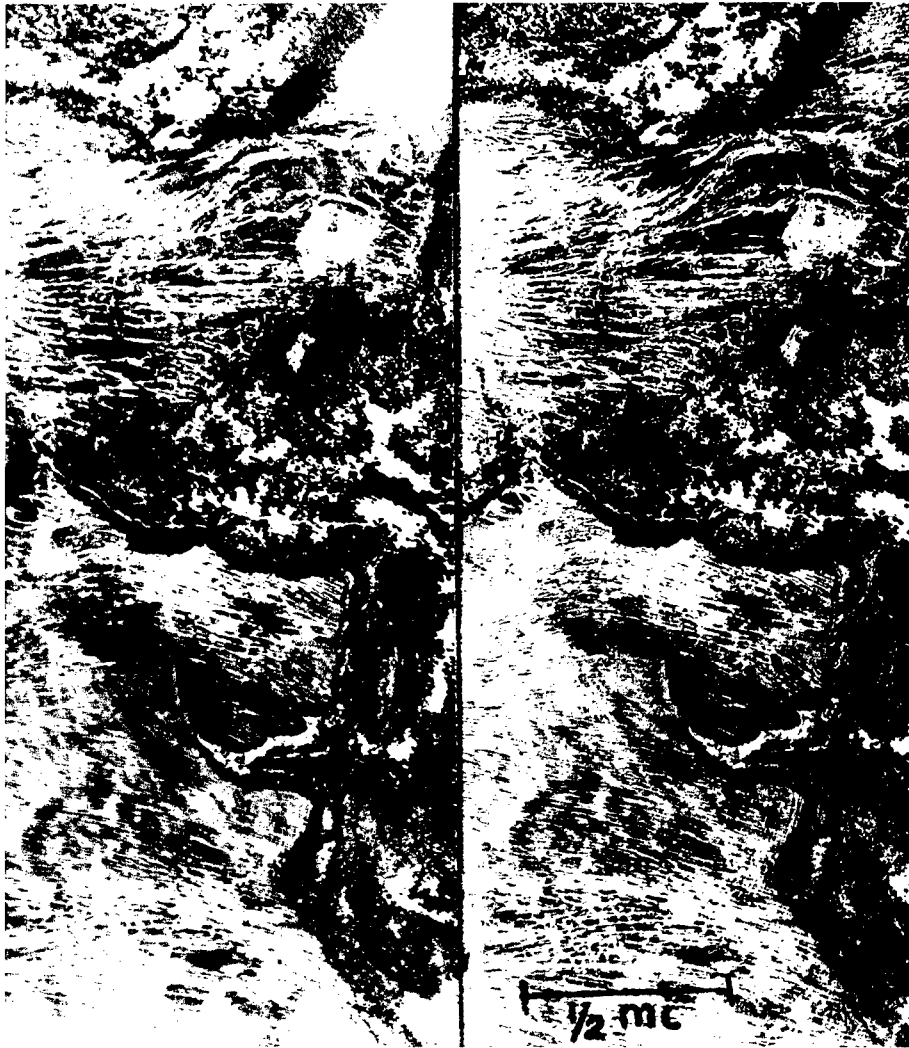
FIGURE 69.—*Stereophoto of a Dissected Basalt Plateau.* This air-photo illustrates one of the many surface features exhibited by basalt flows. Note the streaks or cracks which are contained in the surface. The parallel trend of these may possibly be orientated with the direction of flow of the original deposition. Essentially this area is a high, flat, dissected, barren plateau. Detailed inspection along the vertical faces of the cliff reveals the columnar structure. A change in slope, together with a different pattern of the broad valleys, suggests that the basalt is not very thick and rests on soil of an older period.

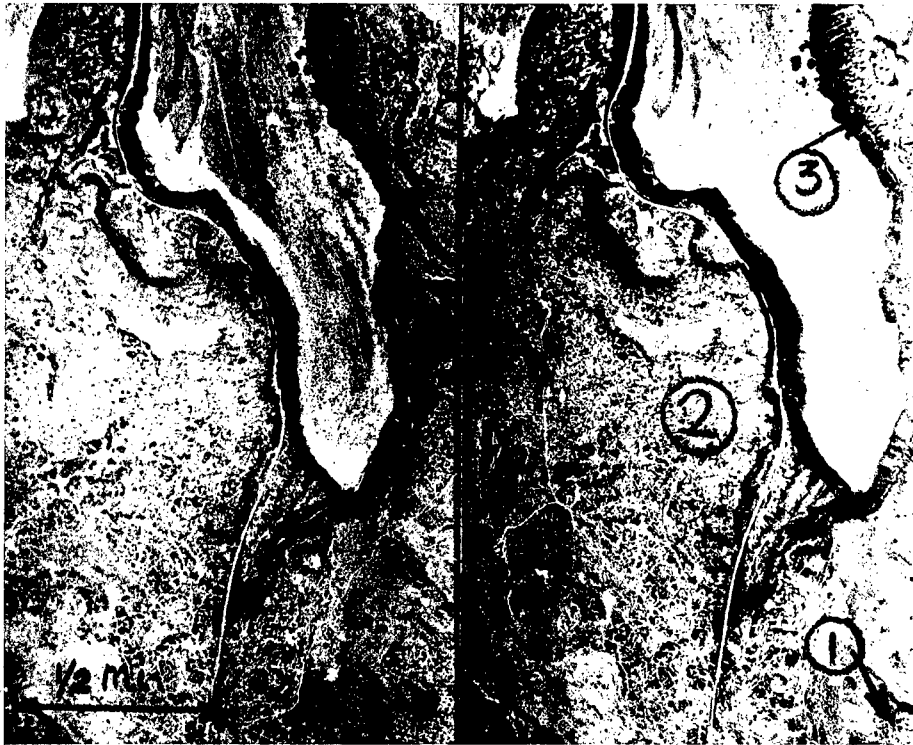
FIGURE 72.—*Stereophoto of a Deep Gorge, or Coulee, in the Columbia River Plateau. There are three basalt flows represented in this photo. The columnar structure of the basalt is exposed along the coulee sides.*

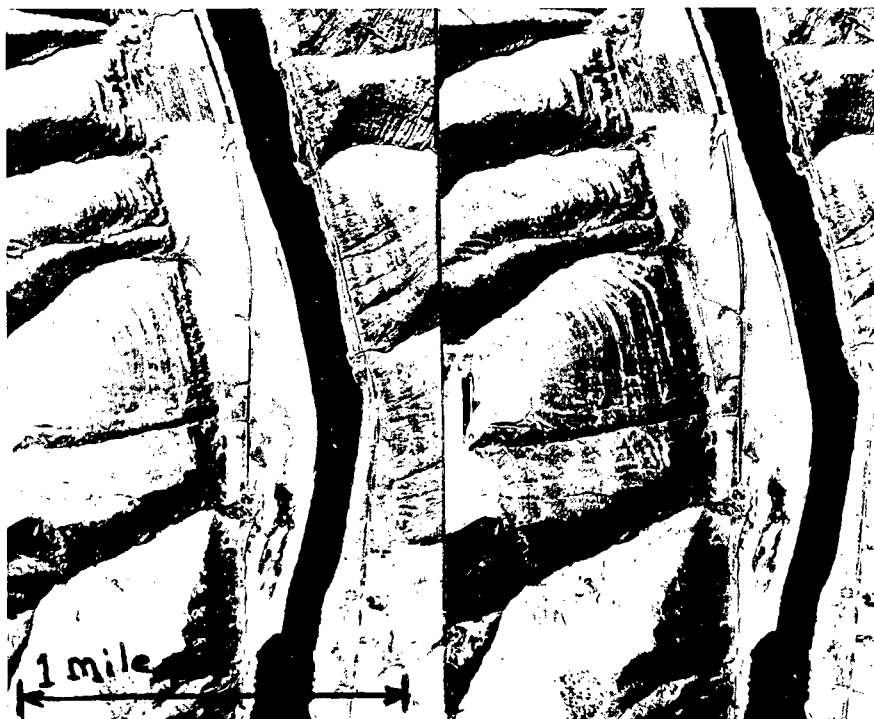
FIGURE 74.—Stereophoto of a Series of Several Basalt Flows Separated by Residual Soil Development (Garfield County, Wash.). See ground photo in figure 75.

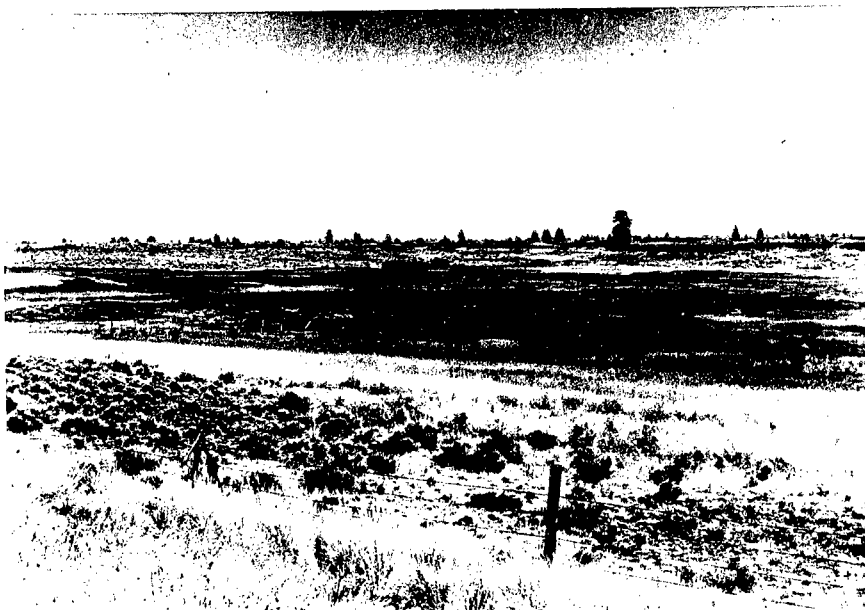
FIGURE 77. *Ground View of a Channel in Basalt (A in fig. 76).* Note the changes in vegetation; there is grass on the upland flats, sage brush occurs on the side slopes and marsh vegetation is supported in the channel.

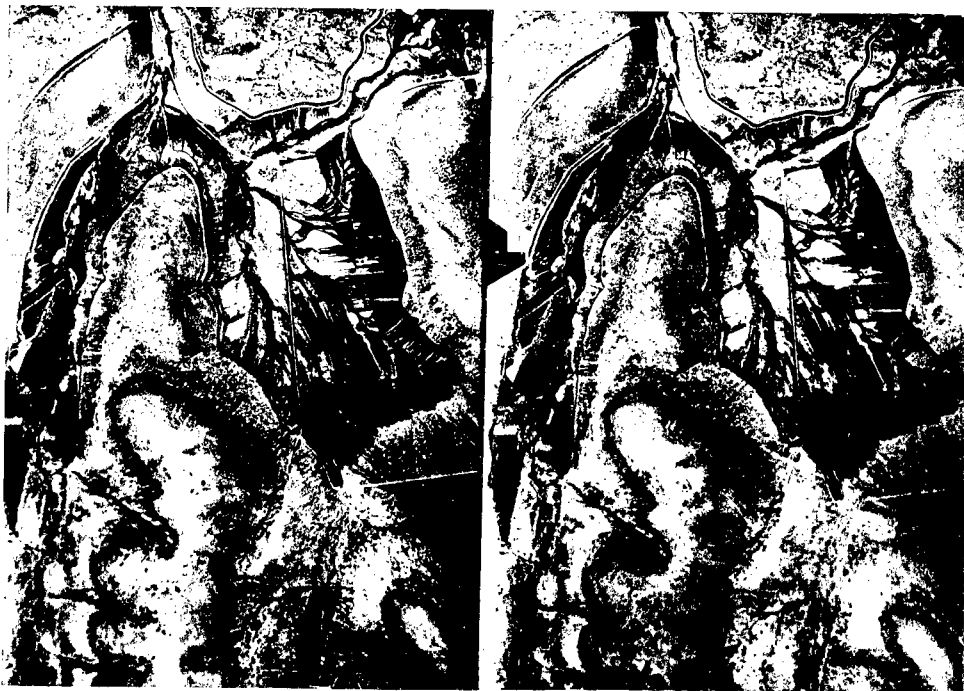
FIGURE 79. *Stereophoto of Thin Layers of Basalt and Thick Layers of Soil Between Basalt Layers (Ellensburg formation). The rounded slopes are produced by the soil mantle and by the soil between the basalt layers. The basalt can be seen as outcropping beds which give a contoured appearance to the hills (Kittitas County, Wash.)*
